REPORT NO. NADC-83123-60

PERFORMANCE EVALUATION OF THE HI-SPEED EJECTION LIMB PROTECTION SYSTEMS (HELPS)

Ken Miller
Aircraft and Crew System Technology Directorate
NAVAL AIR DEVELOPMENT CENTER
Warminster, PA 18974

PHASE REPORT
PROGRAM ELEMENT-63216N
Work Unit No.-W0584001

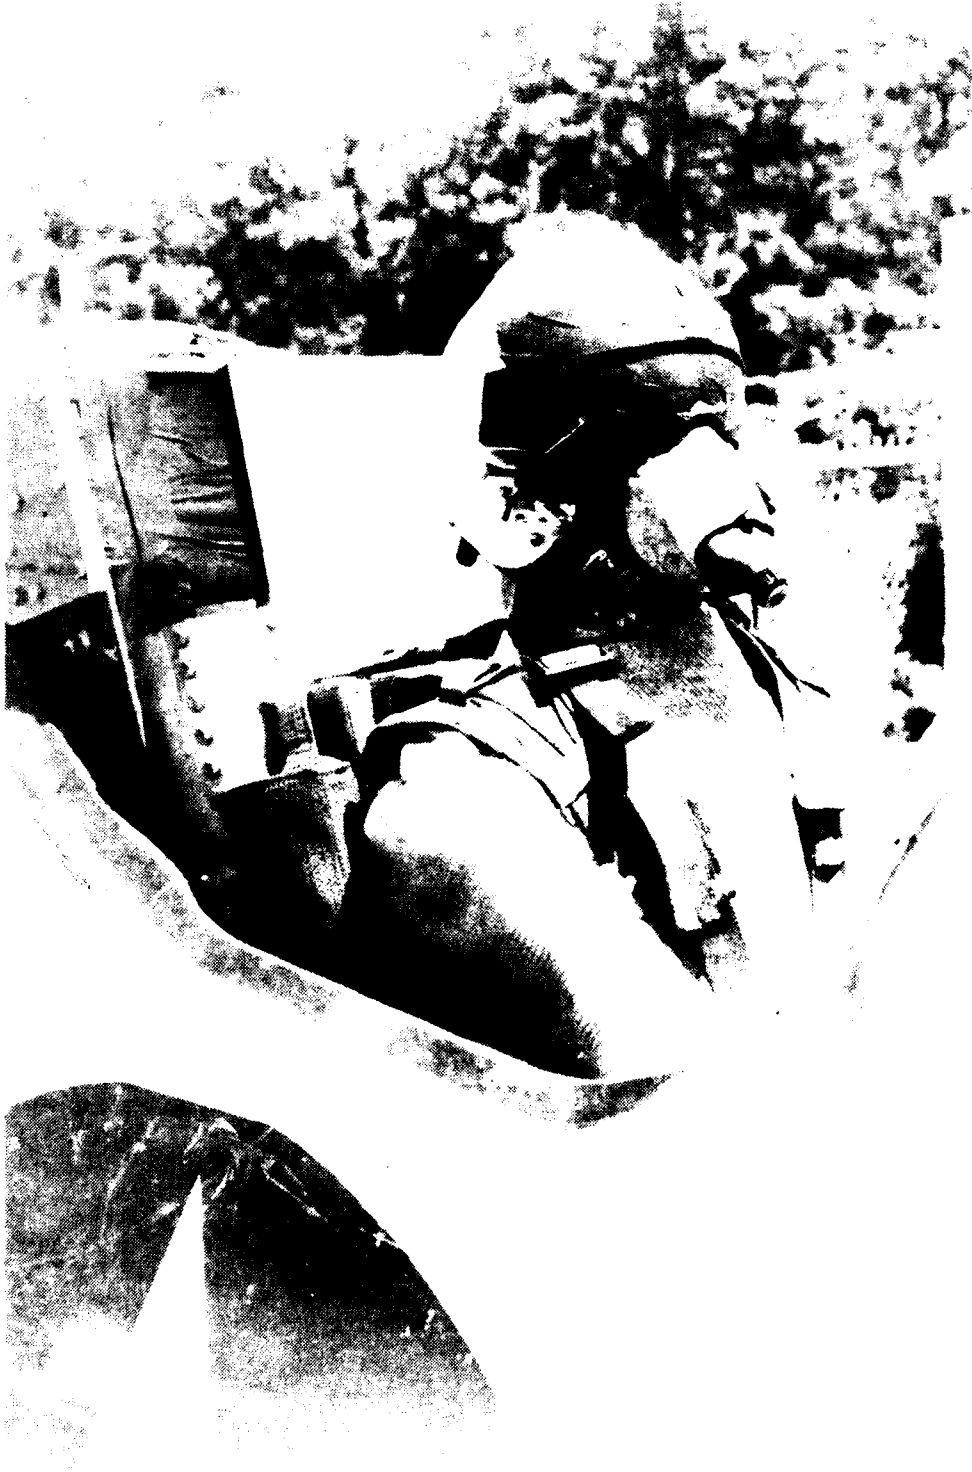
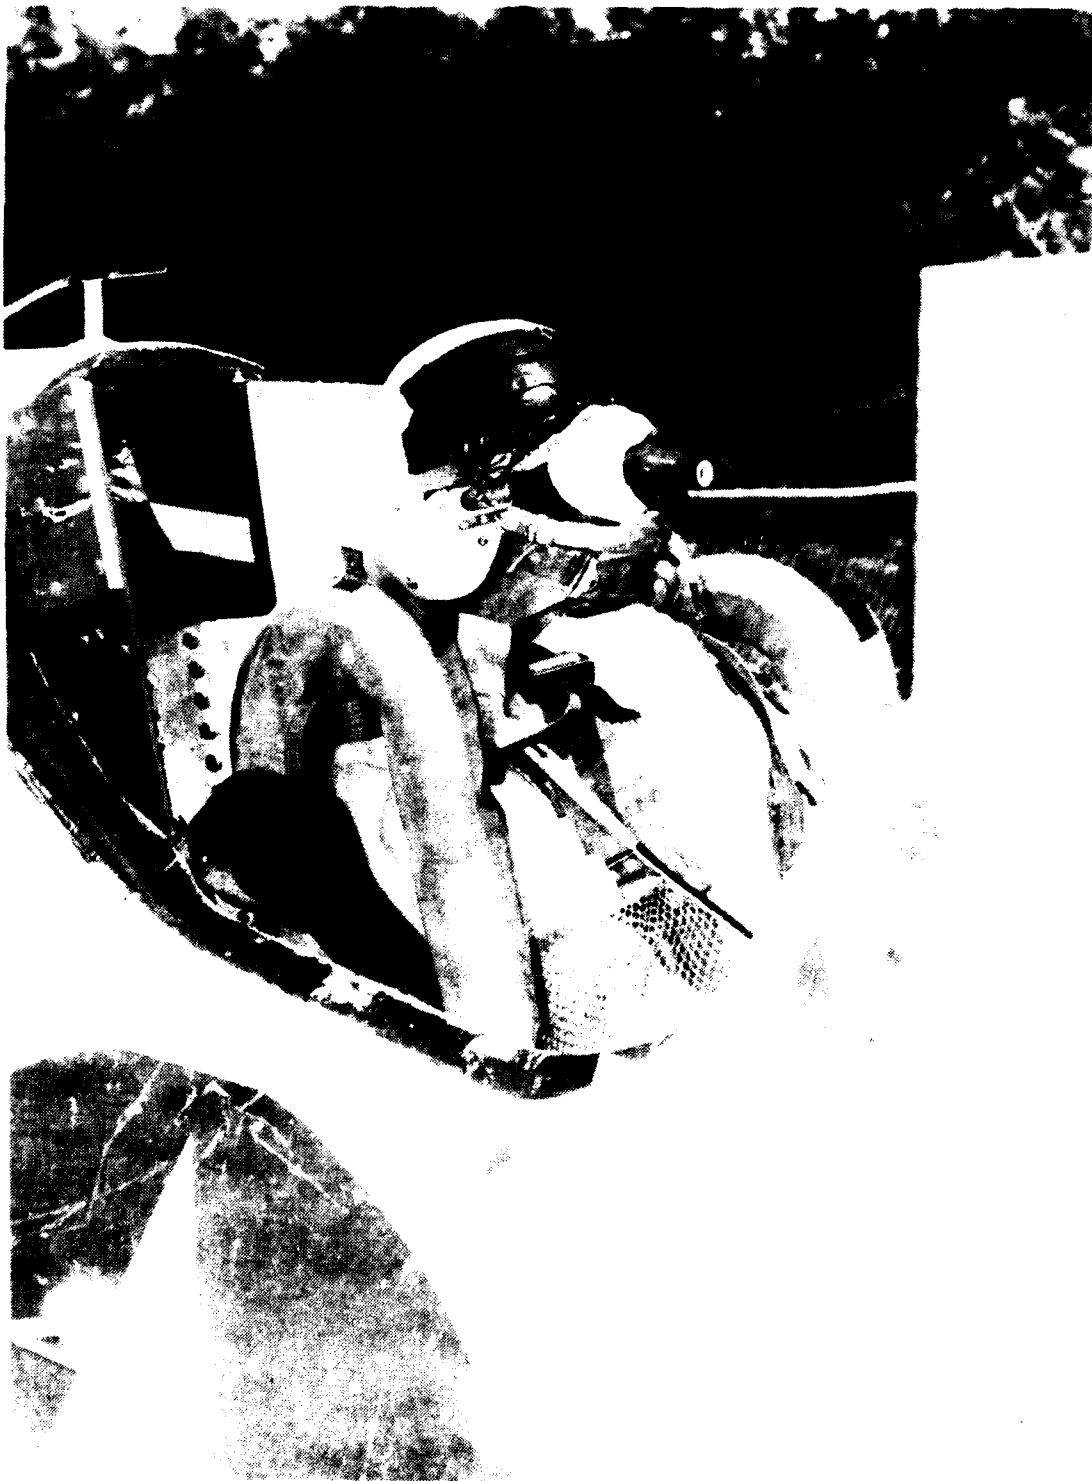
Figures 7 and 8 show the HELPS system before and after test no. 5. Although the HELPS components are in proper position after the test, proper deployment didn't occur. Film analysis showed the bladders hung-up during the still air time between HELPS initiation and airblast initiation. The airblast actually freed the bladders and allowed them to properly deploy.

Figure 7. Pretest View for Deployment During Windblast

Figure 8. Post Test View for Deployment During Windblast

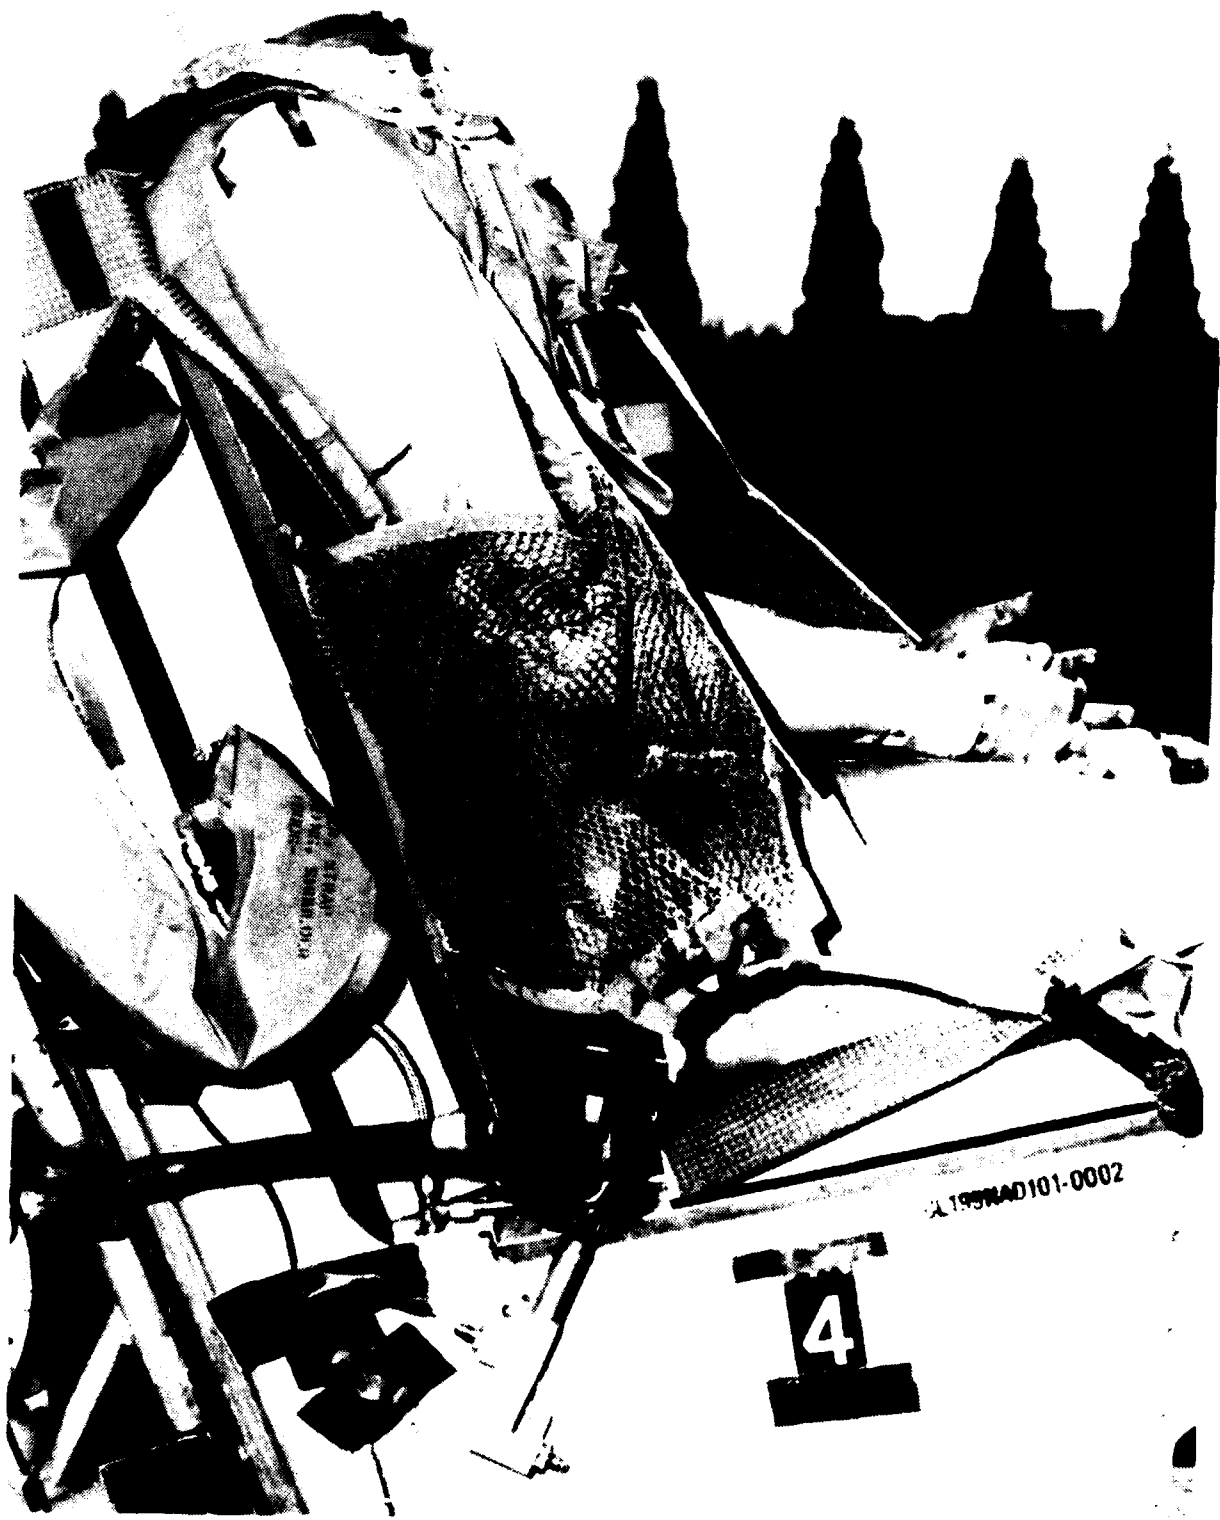
2. The leg restraint lines did not capture the legs, (figures 14 and 16). Three reasons for the failure to capture the legs were evident. These were:

- The bladders were not deployed to their proper position.
- The velcro connection of the leg restraint strap to the bladder prematurely disconnected during the deployment.
- The bladders twisted from their properly deployed position as the leg restraint straps separated from the velcro.

Figure 16. Close-Up of Improper Leg Restraint
